CAPE COD EASTERLY SHORE BEACH EROSION STUDY

VOLUME I
APRIL 1979

**United States Army
Corps of Engineers**

New England Division

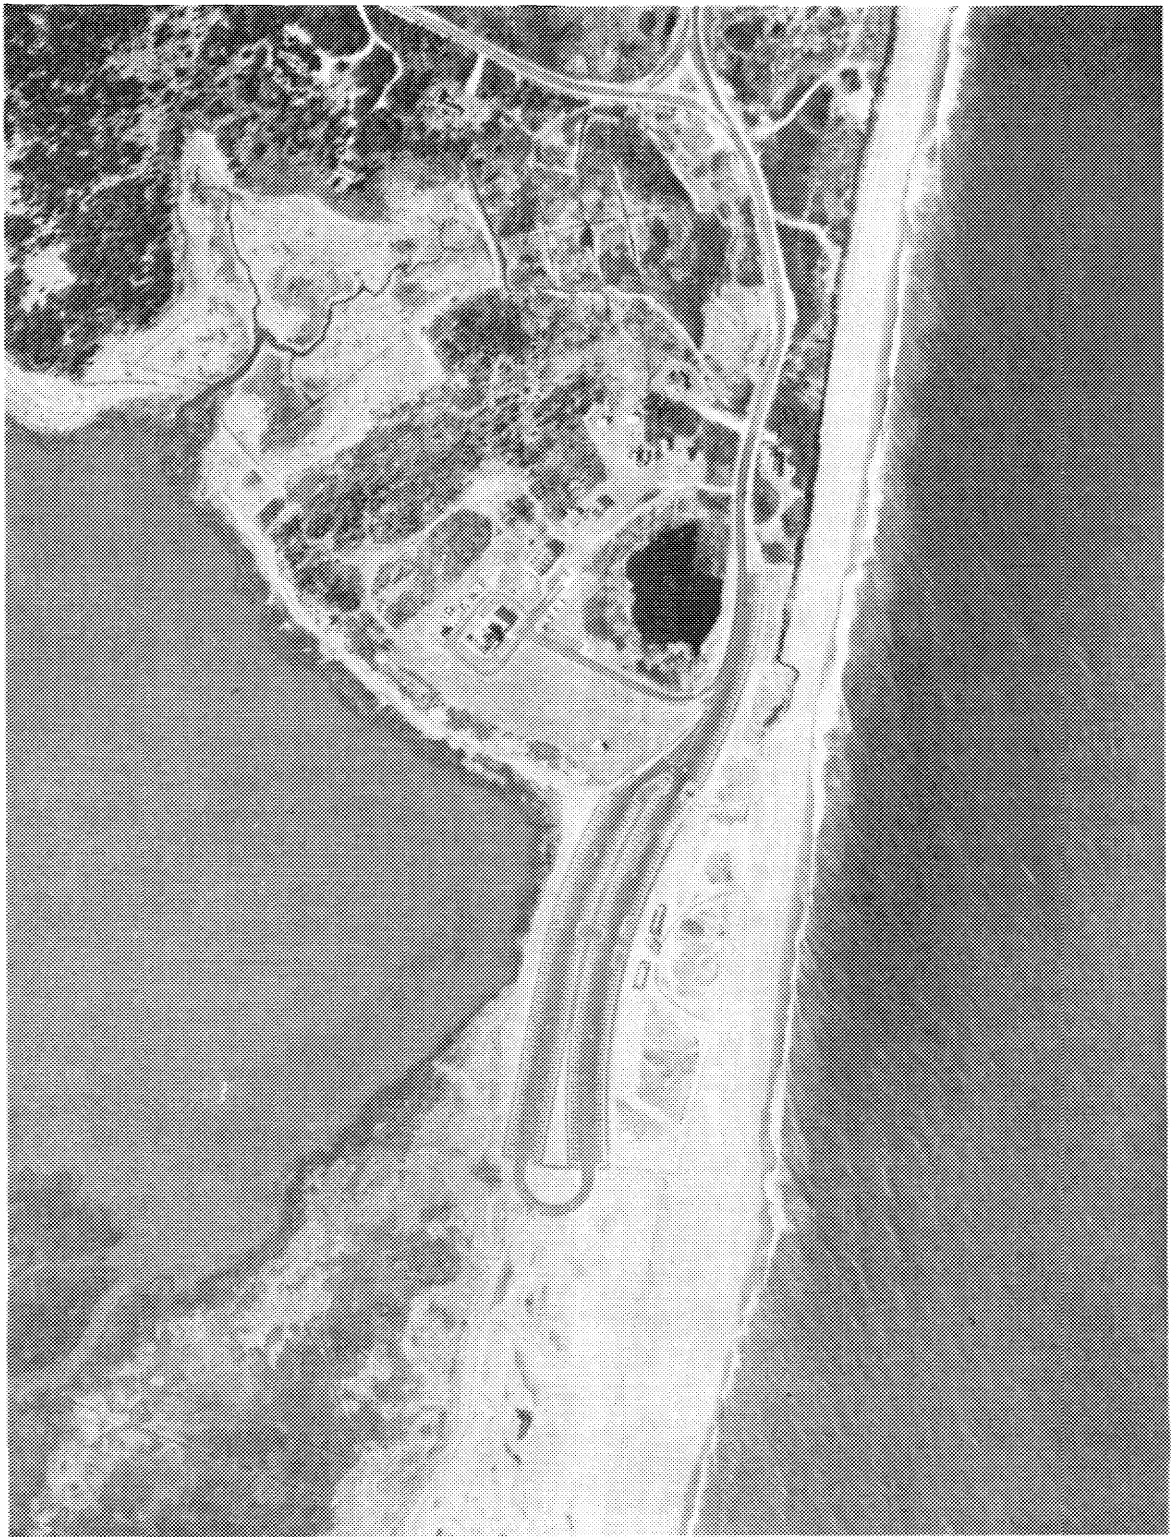
Figure 1. Coast Guard Beach, Eastham, Massachusetts, 1965

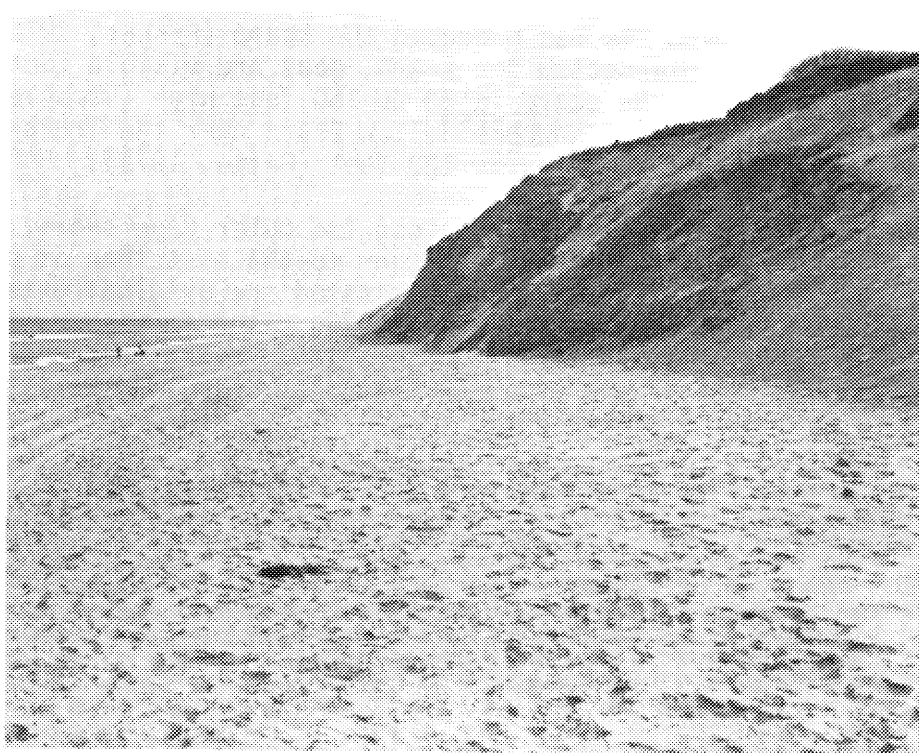
Figure 7. Erosion of the marine scarp, Atlantic coast of Cape Cod, Massachusetts

Recession of the scarp on eastern Cape Cod is caused by erosion of the glacial material on the face of the scarp. Two major factors contributing to the erosion are wave attack on the base of the scarp and erosion of the scarp face by rain and runoff. Rain causes deposition of small fans of clay and gravel at the foot of the scarp (Zeigler, 1960). This material

can then be carried out to sea by waves. Whether waves are able to reach the scarp or the material deposited at the scarp base depends on the condition of the beach. A wide beach protects the scarp base from waves; when the beach is wasted, waves attack the scarp directly (Zeigler et al, 1959).

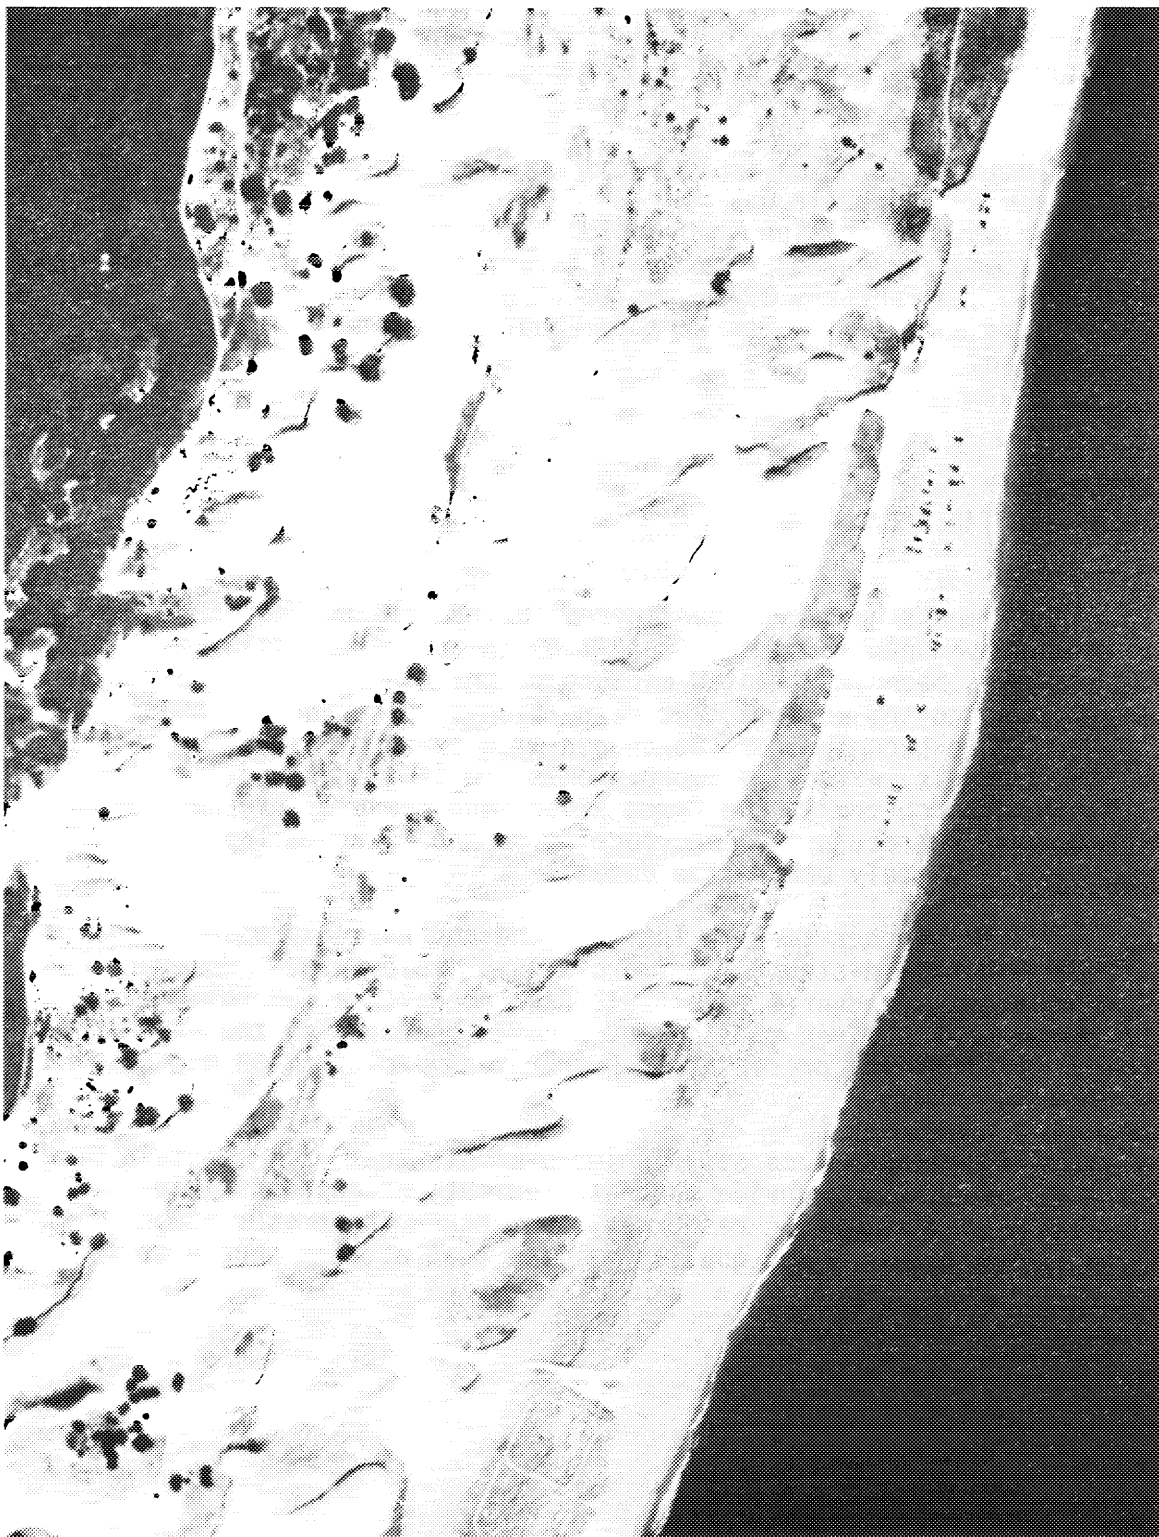
Figure 11. Off-the-road vehicles on Race Point Beach, Provincetown, Massachusetts

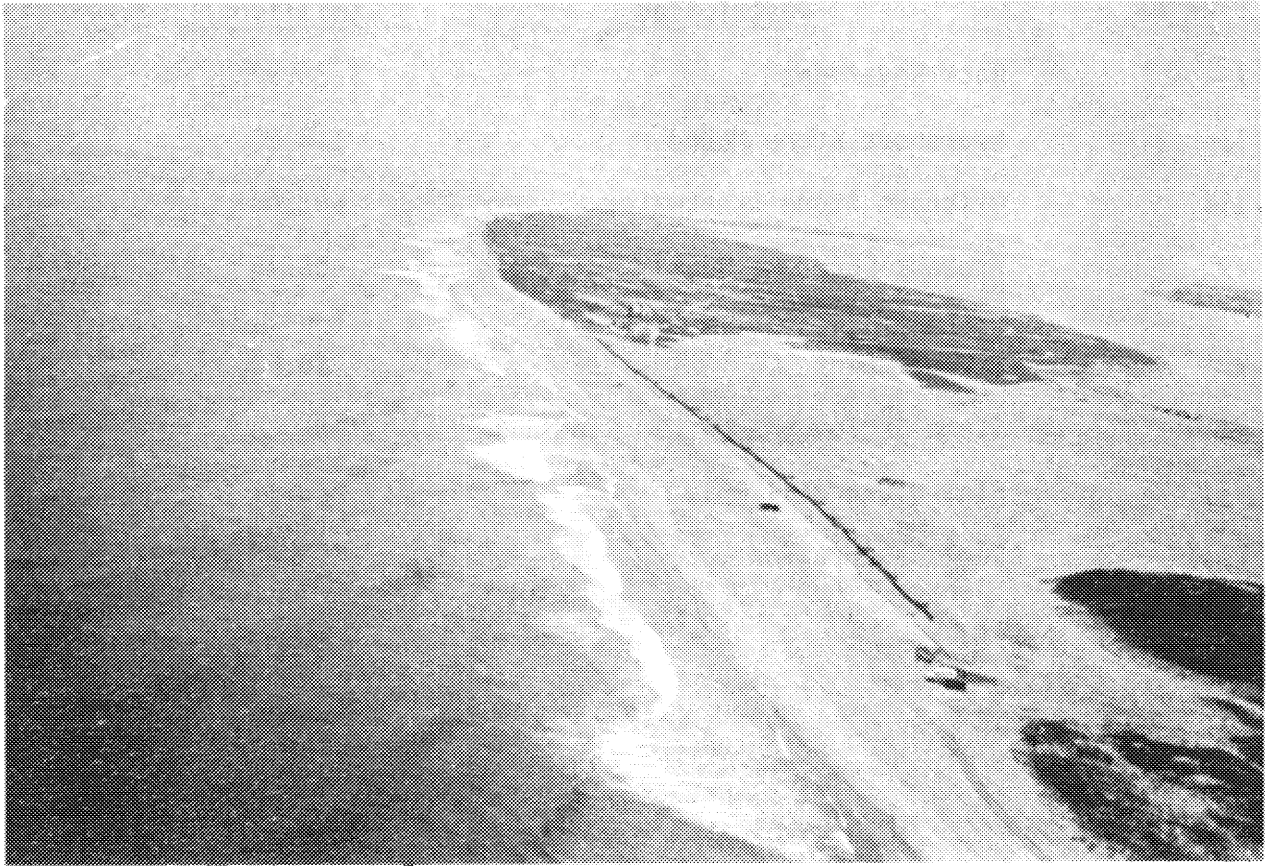
Figure 13. Sand fence experiment near Old Harbor Life Saving Station site, Chatham, Massachusetts
